## **JunoCam at PJ56: preliminary report**

John Rogers (2023 Dec.27)

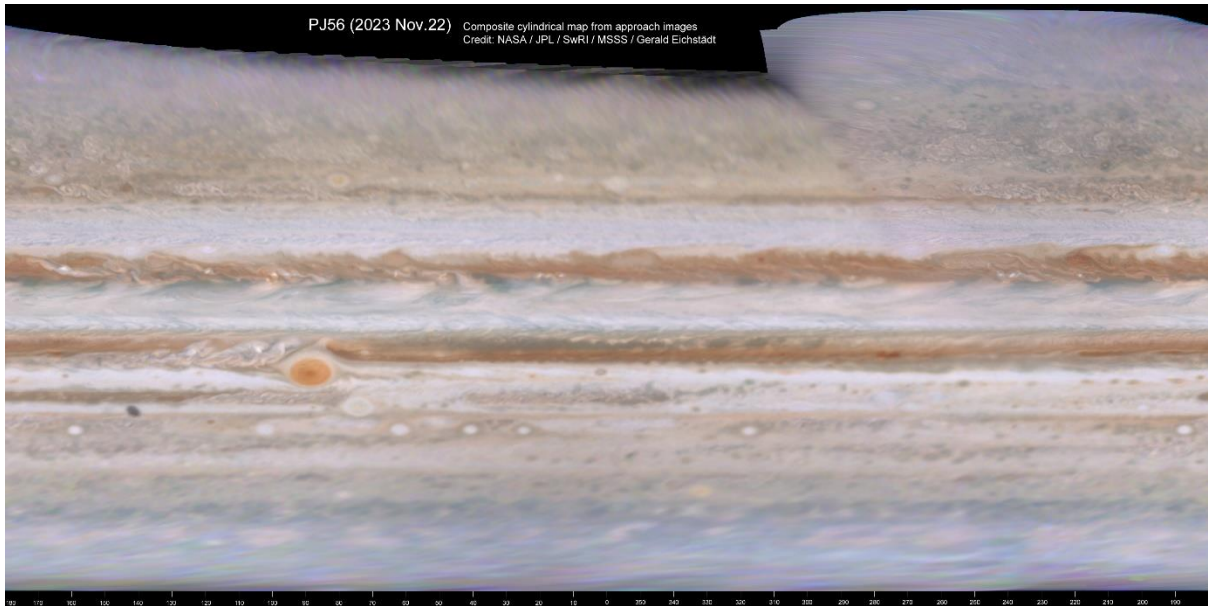
**Figure 1**

Juno's PJ56 was on 2023 Nov.22, with equator crossing (on the dark side) at L3=136. Most of the inbound images were normal, so Gerald Eichstädt was able to make composite cylindrical maps as usual ([Figure 1](#)).

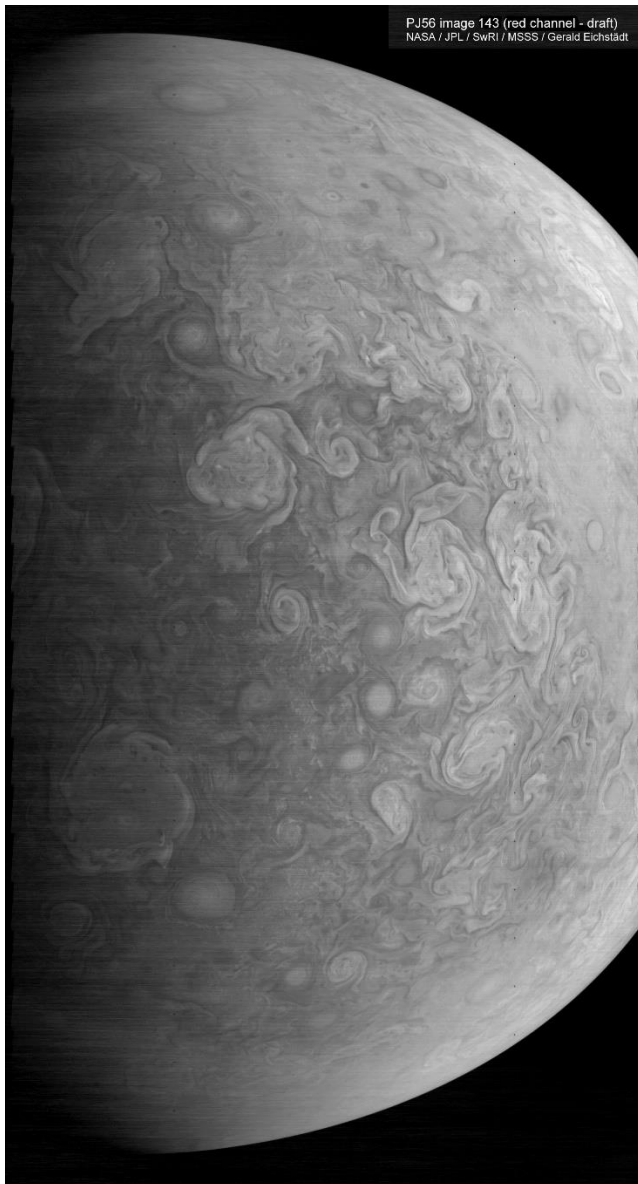
**Figure 2**

The high background and noise are present in all channels so low-brightness parts of images are worst affected, viz. the green and blue channels and near-terminator regions. The red channel is the best, and adequate for the high northern latitudes in the late inbound images ([Figure 2](#)). [In all the figures, I have enhanced the overall contrast.]

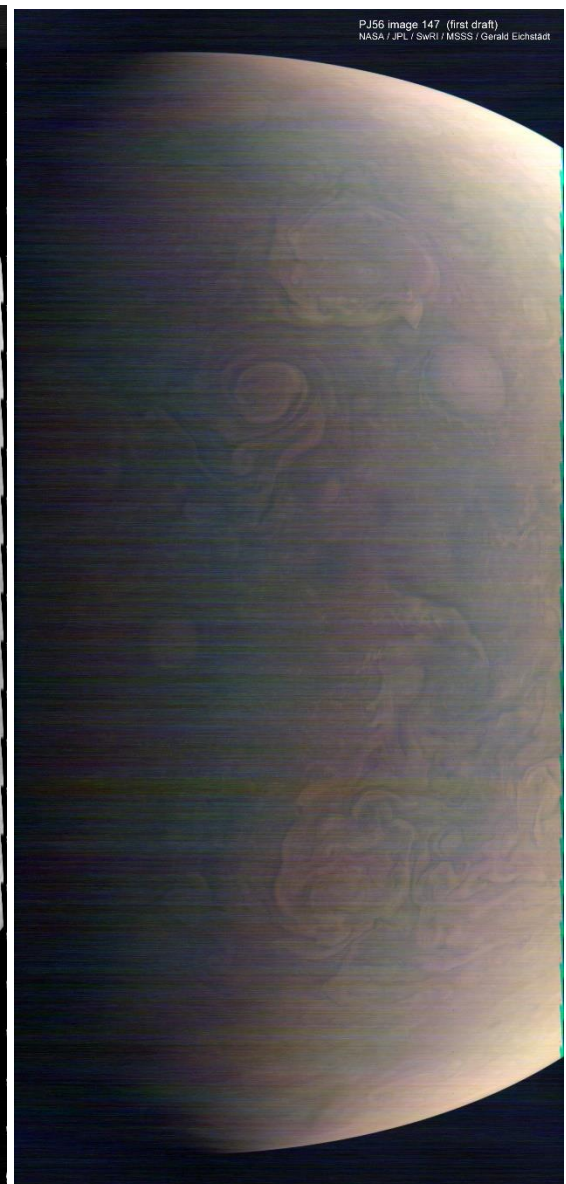
**Figure 3A**

The images of the north pole, important for monitoring the circumpolar cyclones (CPCs), were strongly affected ([Figure 3A](#)). Björn has now processed a pair of these images to remove as much of the noise as possible, and created a north polar map from the red channels ([Figure 3B](#)). Here we can see five of the 8 CPCs and the central North Polar Cyclone, and some of the associated AWOs that we have been tracking. CPC-1 at first glance seems to have a double core: as shown on the map, its anticyclonic core is displaced ‘below’ the geometric centre and there is a large swirl that may be a cyclonic eddy ‘above’ the centre. This asymmetry has been developing gradually over the last few perijoves.

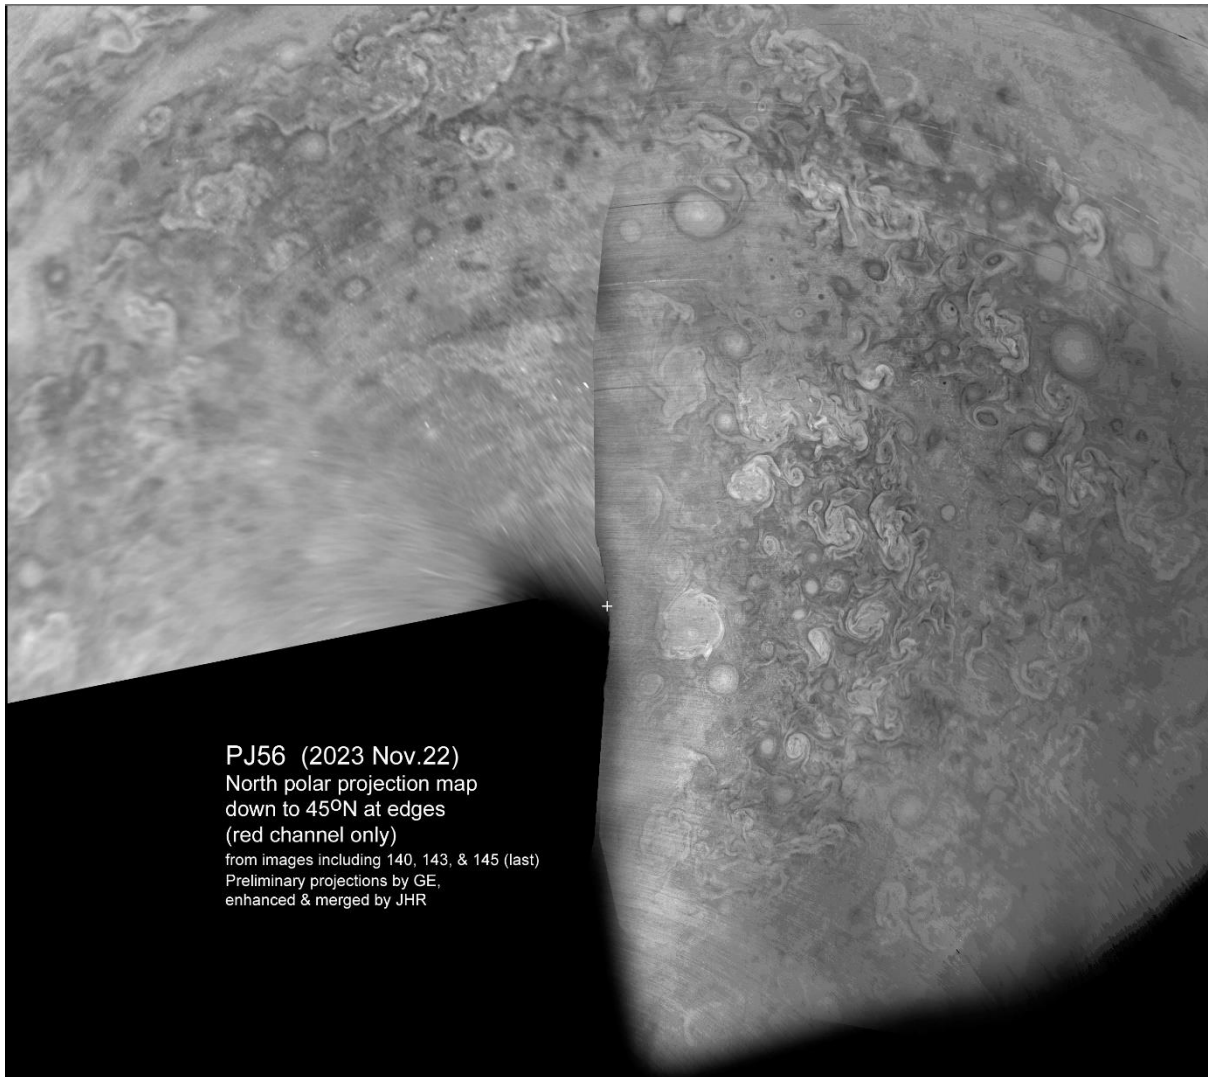
Figure 4

[Figure 4](#) is a composite north pole projection map down to lower latitudes, also using the red channel only, from Gerald’s processing of the uncorrected images. This shows the Bland Zone, FFRs and AWOs, and allows comparison with maps from PJ55 and PJ57 and from hi-res amateur images in November.

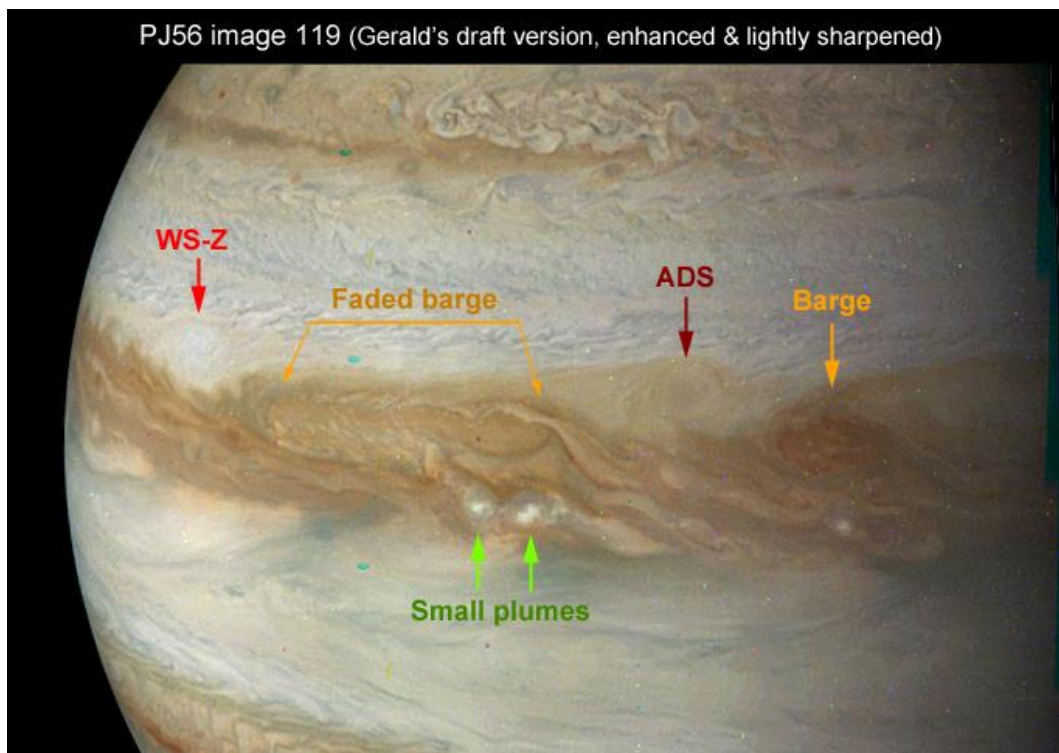
Figure 5

The inbound images included the same interesting sector of the NEB as at PJ55 and PJ57, so [Figure 5](#) can be compared with figures in those perijove reports.
